EXCEL BUILDING SURVEYORS

SAMPLE BUILDING SURVEY REPORT

SAMPLE PROPERTY

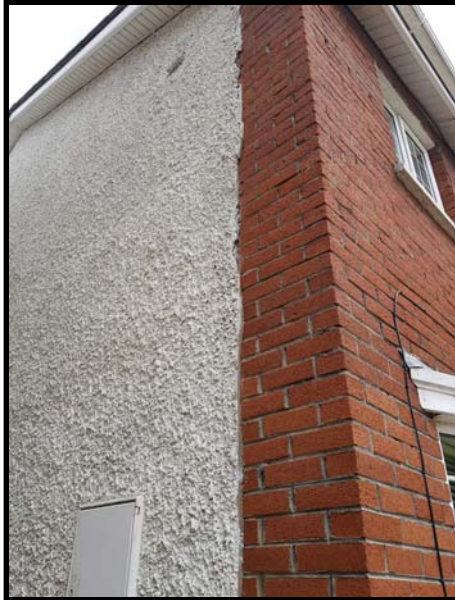
Some minor damage is noted to the render finish at the junction of brickwork and roughcast render to the gable wall, some repair works will be required here in future.

1. Cracked render at junction gable wall and brickwork

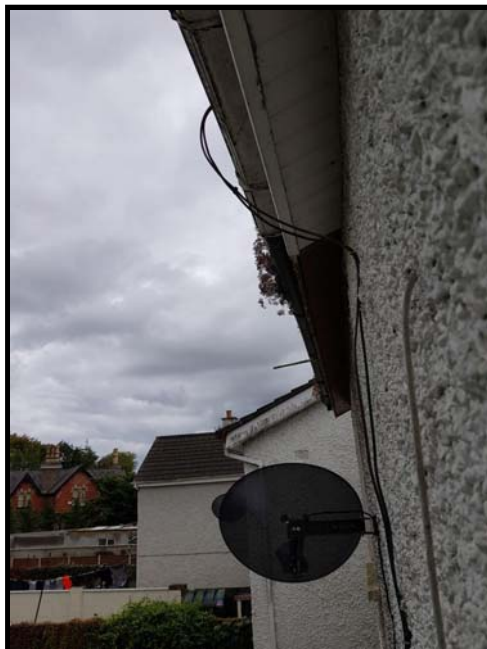
There is no downpipe to the rear gutter and this is poorly connected to the gutter of the adjoining house. Leaks are apparent in this area. You might consider a few options to improve this, such as

2. Rear elevation, leak at rear gutter

- (1) requesting the neighbour to allow an improved connection with new gutters and downpipes on their side of the property.
- (2) provide a new downpipe on your property connected to the gutter and drained to a suitable soakaway.

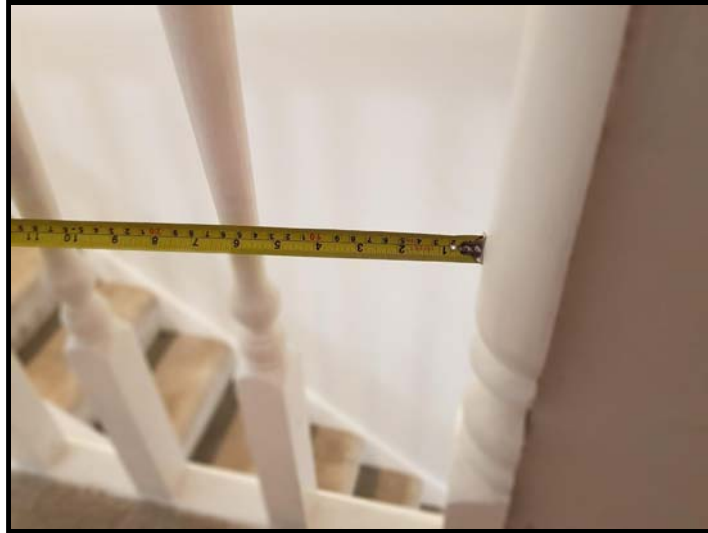
However, it should be noted that the spacing between the balustrades at landing level is in-excess of 140mm in several locations. This could pose a health and safety hazard for very young children.

3. 150mm spacing between balustrade at landing level.

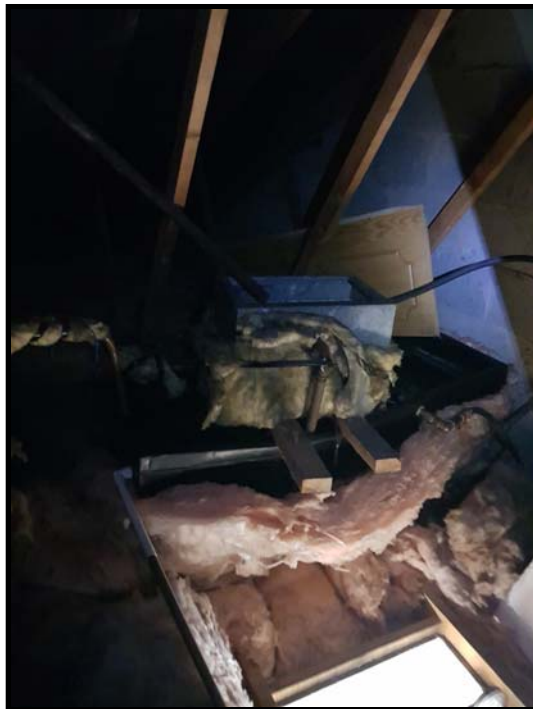
The PVC cold water storage tank is located in the attic. Unusually this is used to support a fabricated metal expansion tank on two small pieces of timber. Both tanks are poorly supported and ideally this situation should be improved. In particular, the smaller expansion

tank should have individual support. The PVC water tank was not designed to carry this type of loading. The large tank should also be provided with a dust cover, and thermal insulation on top. It would appear that the current arrangement has been in place for a number of years.

4. Expansion tank, supported on cold water storage tank in attic

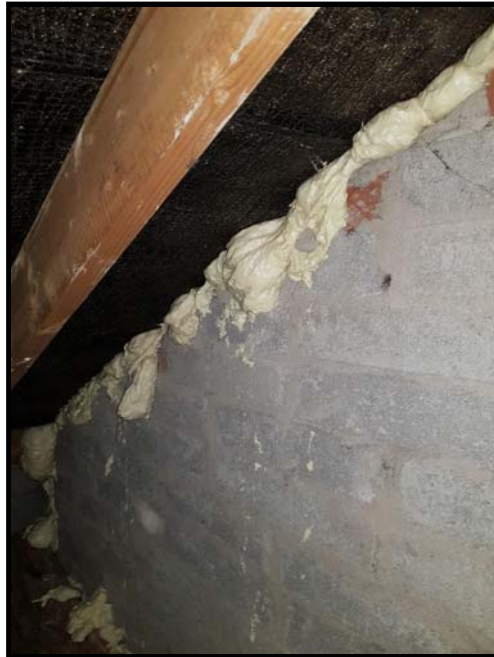
However, the detail of the party wall junction at the roof felt and timber battens supporting the external roof tiles appears to have been altered previously. Ideally a non-combustible layer of rockwool (or a similar material) would be fitted between the top of the wall and the roofing layers above. The foam materials in this location are unlikely to meet any fire proof standard. Please note any alterations to a party wall would require the agreement of the adjoining neighbour.

5. Expanding foam installed on top of party wall in attic

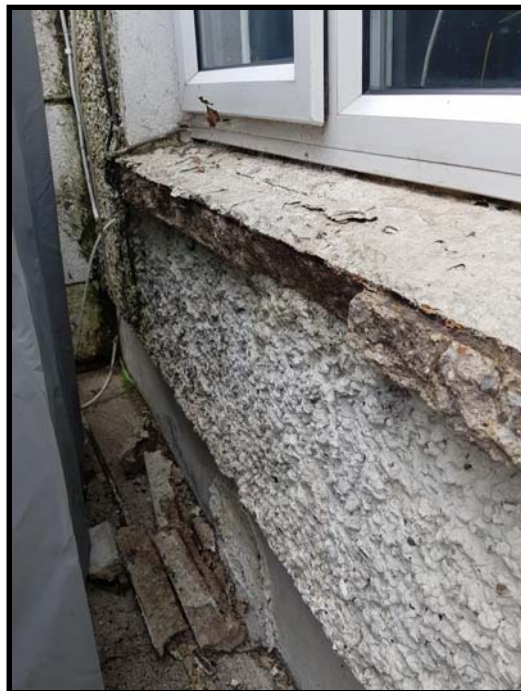
The window sill at ground floor rear sitting room is in poor condition due to oxidation of steel reinforcement, causing the concrete to crack and break. This should be repaired or replaced.

6. Damaged rear window sill
